**Society of International Gas Tanker
& Terminal Operators Ltd**

FIRE PREVENTION
IN THE CARGO CONTAINMENT SYSTEMS OF
LIQUEFIED GAS CARRIERS
IN SHIPYARDS

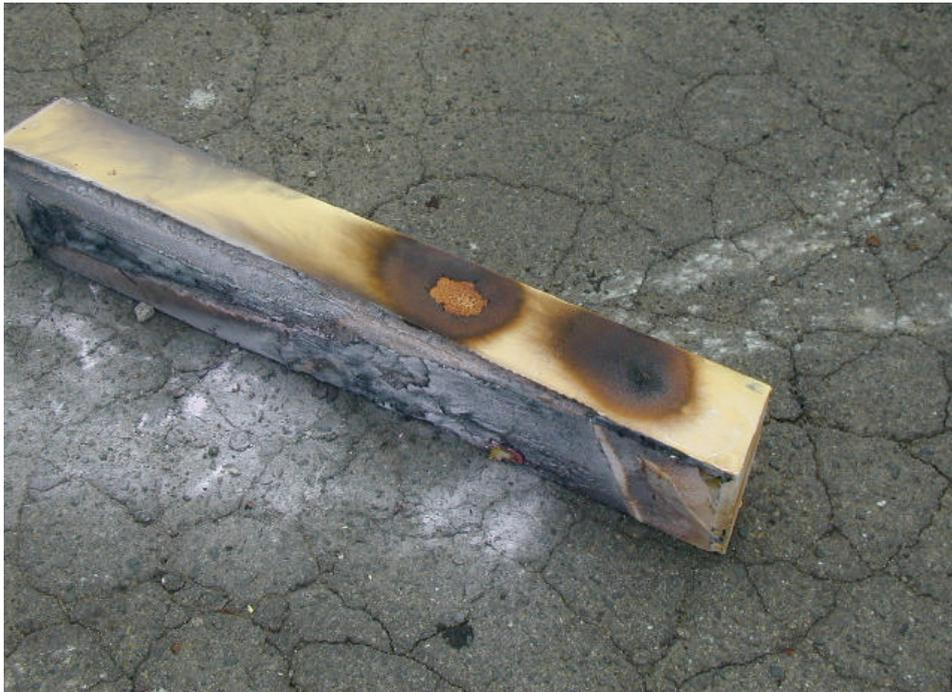
“The first photograph shows a section of foam that we ignited with an oxy-acetylene torch. As per the material specification there was very little smoke or flame and the foam rapidly self extinguished.”

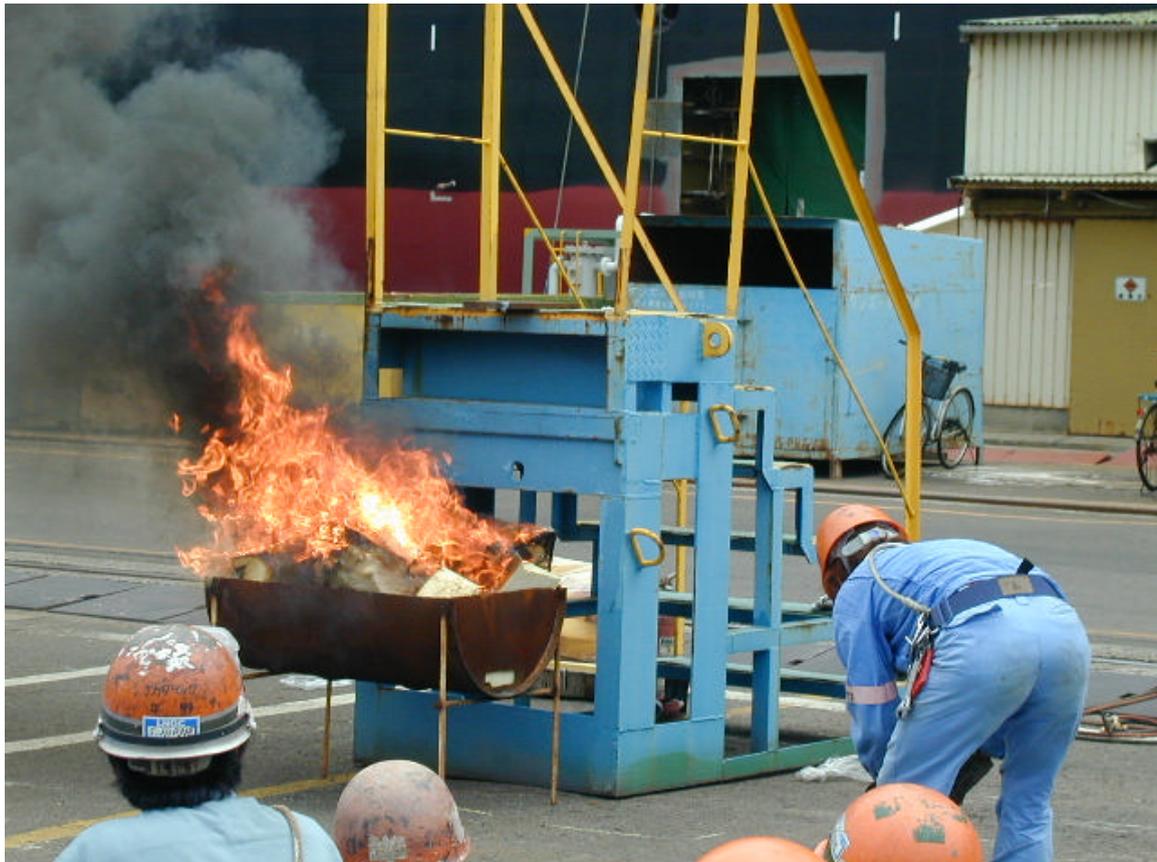
The second photo shows a drum containing off cuts of foam wrapped in polythene bags. This is the way the foam scraps are collected on board and transferred to the skips on the jetty. A burner was used on a piece of steel plate on the platform above the drum. The cutting sparks quickly ignited the polythene bag, and the bag and foam burnt rapidly with large flames and a lot of dense black smoke. As you can see from the photos, the difference is quite remarkable.

The foam by itself is very safe, but the addition of the polythene bags makes it potentially lethal.

Off-cuts of foam insulation materials should be collected and stored in steel drums with lids and NOT polythene bags; as the bags may be ignited by sparks and it has been shown that burning polythene reacts with the foam to intensify the combustion. See appendix 2
